RICS
HomeBuyer Report ● ● ●

LONDON

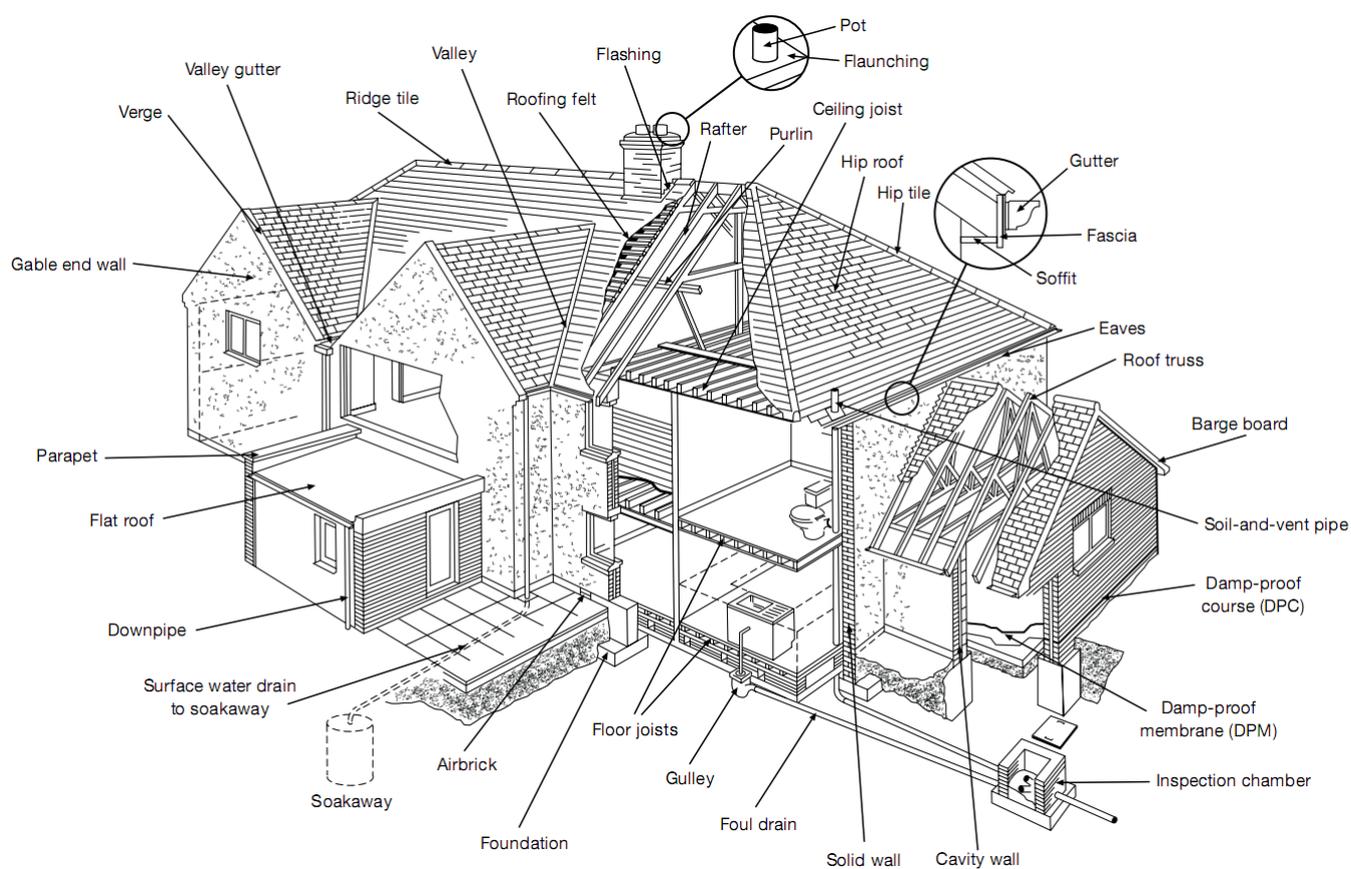
Typical house diagram

This diagram illustrates where you may find some of the building elements referred to in the report.
